WHITMANS POND DAM

MA 00775

PHASE I INSPECTION REPORT
NATIONAL DAM INSPECTION PROGRAM

AUGUST 1980

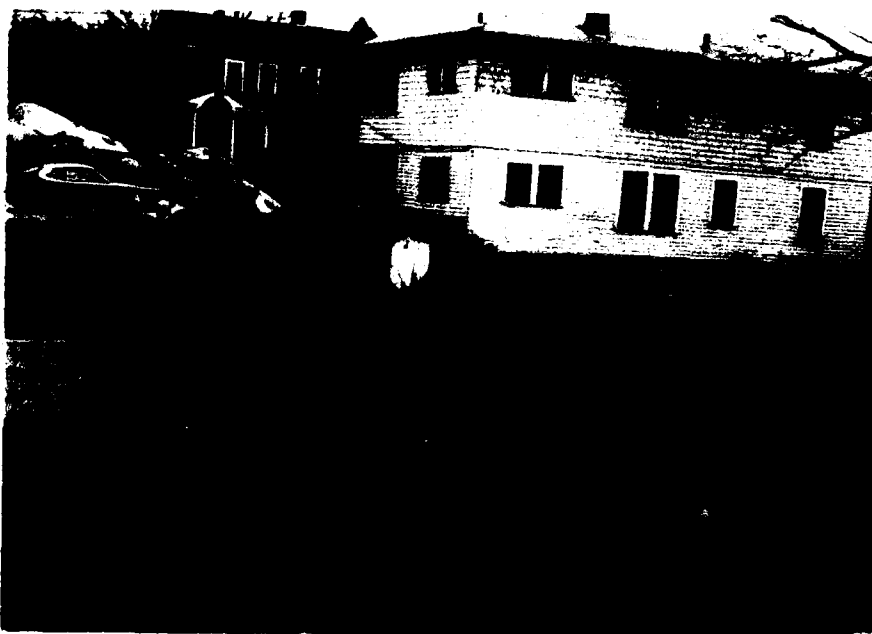
Photo #8 is a view of the right training wall of the approximately 350 ft. long spillway approach channel. This rubble masonry wall is part of the older dam which was replaced in 1935. The wall appears to be in good condition in spite of the fact that the joints are not mortared.

8. Right training wall of the spillway
approach channel
